Urban Flood Risk Impact on Road Accessibility and Socioeconomic Life in Egor Geographical Area of Edo State, Nigeria

OSAGIE JOSEPH EGHAREVBA, AMASIKOMWAN FESTUS ATEWE
University of Benin, Benin City, Nigeria.

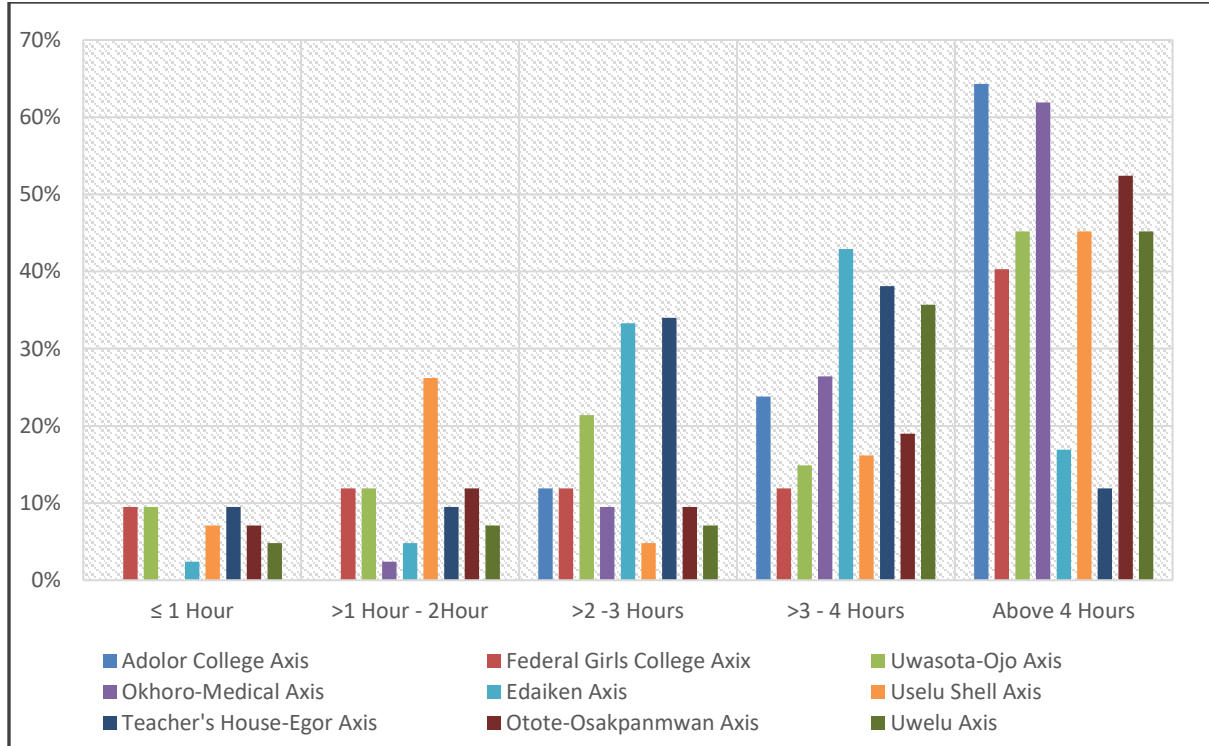
Figure 1: Duration of Flood Waters by Zones/Axes Before Drying Off
Source: Authors’ Field Survey, 2023.

The investigation revealed that the zones/axes with the most severe flooding were also found to coincide with locations having the longest period of stagnant flood waters before total percolation into the ground. Specifically, Adolor College, Okhoro, Federal Girls College and Uwasota-Ojo axes were ranked in the respective order as the first, second, third and fourth locations with highest duration of stagnant flood waters after a downpour before total percolation (Figure 1). This was observed to be possible as most of these locations had similar capacity of drainage system that ensured that the time taken for flood waters to disappear after rains were not likely to be significantly different from place to place in the study area. Again, while this study did not attempt to assess the features and characteristics of soil in the different location, however, the percolation power of soil in the different locations were not also expected to be significantly different from location to location, because the entire Benin City should have the same soil type. In terms of the time taken for the rain waters to run off after a downpour, similar to the Table 2, it was discovered that zones like Adolor and Okhoro axes with a proportion of 64.3% and 61.9% respectively took more time (4hours and above). It was further revealed, that different length of time was required for the flood waters to dry up almost completely in the different sample locations, with the recorded total length tended to be longer than two hours in most of the locations (Figure 1). However, from the bar chart analysis (Figure 1), it could be argued that places which experienced severe flood after a downpour similarly experienced longer time for the rain waters to run off, and this was a major observation during regular field observation.

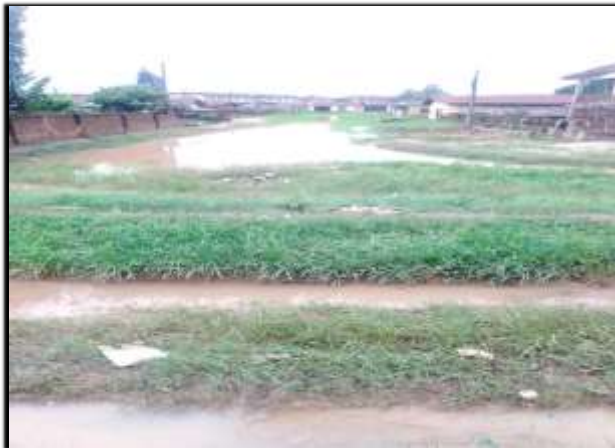
Plate 1: Clogged Earth Road with Flood Pondages and Plants Recovery at Edaiken Avenue by Uselu Traditional Grounds
Source: Authors' Field Survey, 2023.

According to Mao, Zhu and Duan (2012) and Rentschler *et al.*, (2019) in Okechi (2023), flooding reduces transportation network capacity, either directly through physical destruction rendering roads unusable or through floodwater accumulation on the road surface thereby rendering them impassable. Both cases have been observed to trigger severe localized accessibility problem that can later become large scale concern in the study area (see Plates 1 and 2). Many roads in the study area are characterised with absence of drainage facility, pot holes, flood pondages, plant and soil recovery, which poses accessibility challenges even among trekking pedestrians.

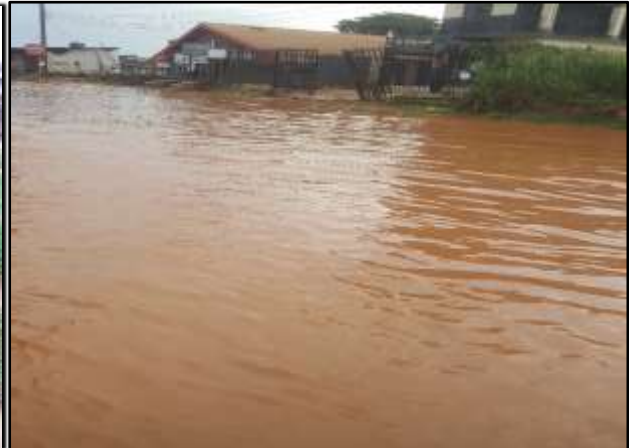
Plate 2: Submerged Portion of Uselu-Lagos Road, by Tomeline Engineers.
Source: Authors' Field Survey, 2023

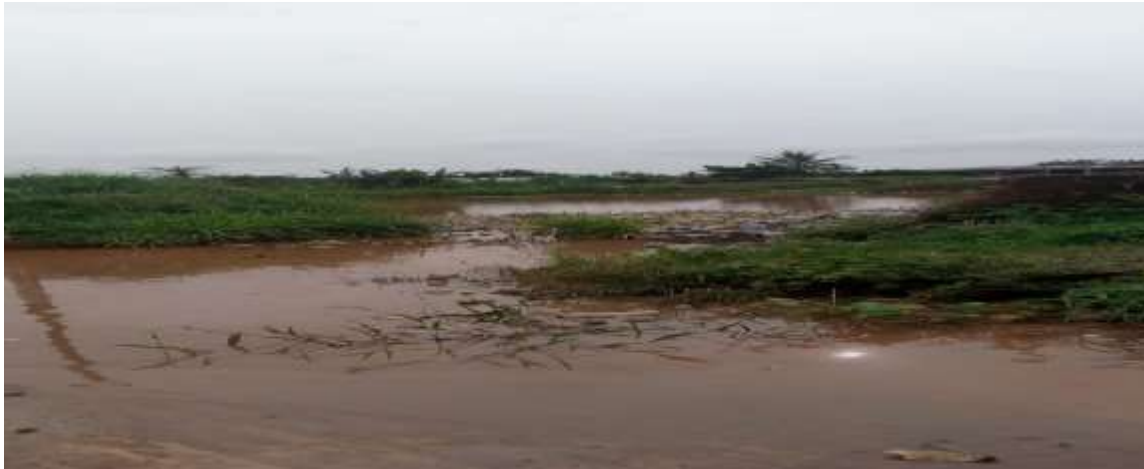
Plate 3: Flooded Portion of the Popular Uwasota Road by Ojo Junction in Benin City.
Source: Authors’ Field Survey, 2023.

The position of road networks was loud because in the study because, the roads were observed to represent the key channels of flooding and flood related damages. As property owners scramble for the safety of their property in many flood-ravaged districts of the study area, the roads have become targeted points of flood water channelization and control. The implication of this new dimension of flood water control by the local people is that, most of the community roads, especially the untarred ones are left in shape where they can hardly support accessibility all-year round. While it is obvious that government presence was lacking in many zones of the study area (Plate 3), however, intriguing was the negative attitudes of the people towards flood management and maintenance.

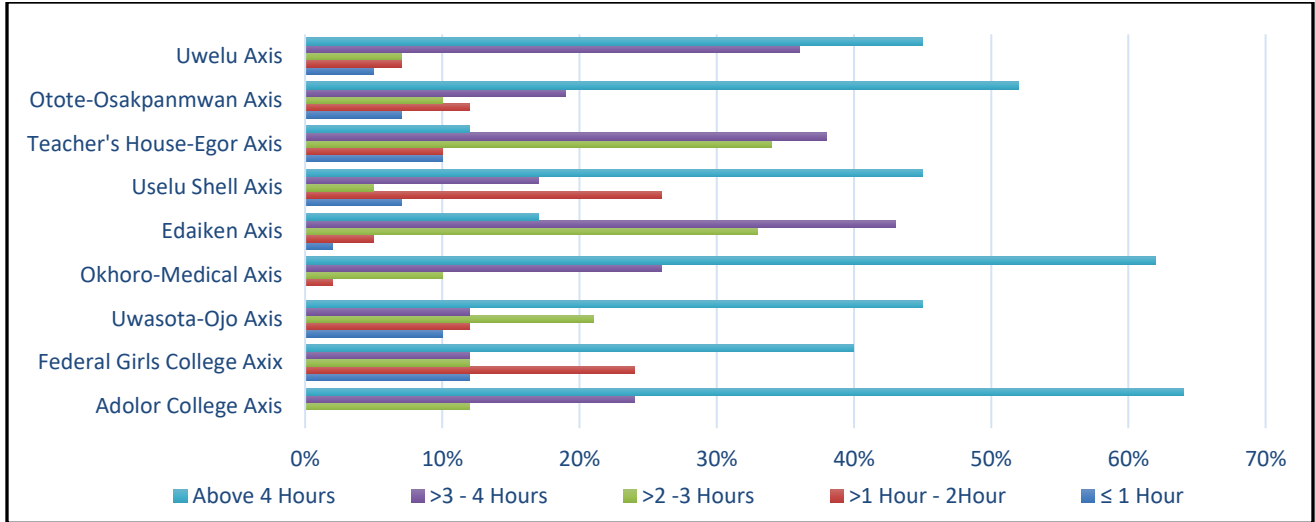
Figure 3: Length of Restriction to Movement After Rainfall by Zones
Source: Authors’ Fieldwork,2023.

In terms of the how long the restriction last, it was discovered that Adolor and Okhoro-Medical zones with a proportion of 64% and 62% respectively took more time (4hours and above). Other areas of high percentage response for similar duration include Otote-Osakpanmwan, Uselu Shell and Uwelu and Uwasota-Ojo zones (Figure 3). When compared to Table 2 (of severity of flooding), it was evidence that, areas with high severity of flooding were also areas of noticeable long period of movement restriction across the study area.

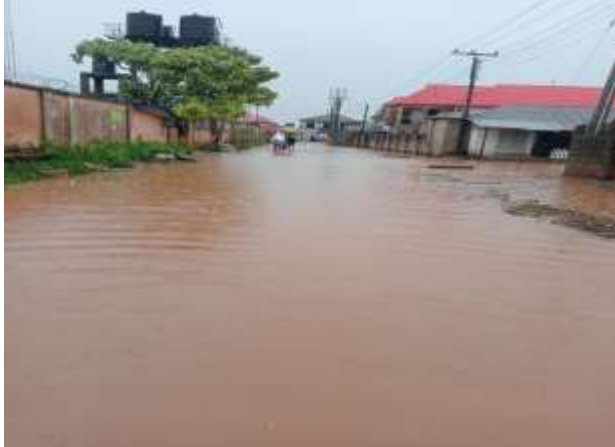
Plate 4: Submerged Portion of Collector Road At Equalaba Street, Beside Uselu Psychiatric Hospital, Benin City. Authors' Field Survey, 2023.

Field observation revealed that many of the roads leading to districts in the study area were almost in a state of inaccessibility during rainy season (see Plates 4 and 5). These roads are mostly the untarred local earth roads which

are the most in number and connect almost everywhere in the LGA. These roads therefore, help in serving local access to residential neighbourhoods and also serve useful role in exchanging traffic between them and the major arterial roads that connect the entire urban space. But, because of their very nature in which most of them have unpaved earth surfaces, and with absence of functional drainage system that can help to reduce the effect of caving in flood waters, therefore, flood waters often damage them easily, turning them into channels through which the entire urban environment was ravaged by flood menace. According to Buren and Buma (2012), water that stagnate on roads due to lack of good drainage system or any better means to prevent flooding leads to traffic congestion and stagnation, and if the water should reach a certain level or depth, this can lead to traffic stoppage.

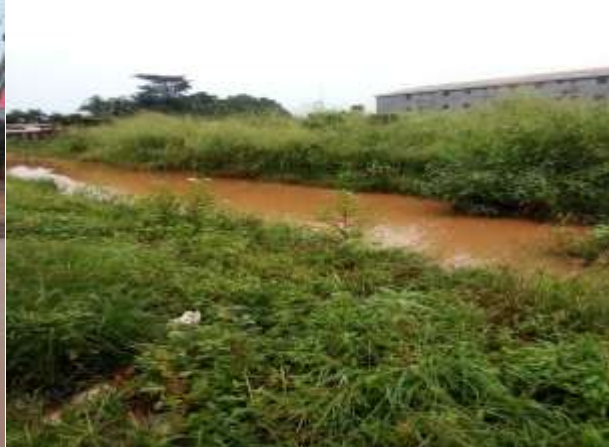
Plate 5: Flood-Ravaged Aburime Street, off Federal Government Girls College Road, Ugbowo, Benin City. **Source:** Authors' Field Survey, 2023.
